# **Van Guard**

## **Sled Test Report**

Roof Rack Frame (Maxrack)  
Ladder Clamps  
Pipe Carrier

**A257I03**

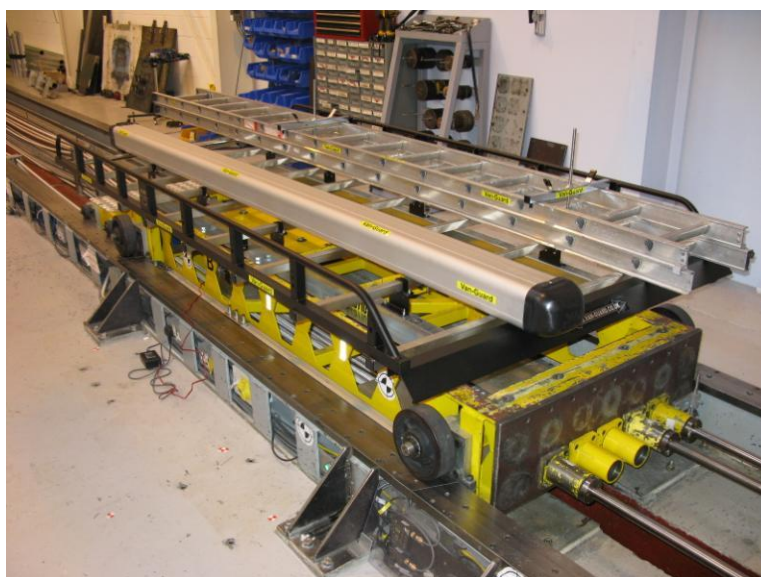
- Roof rack frame with associated brackets, attached to the sled at 4 mounting positions on either side
- One pipe tube containing 60 copper pipes attached to the roof rack frame in two places
- One ladder attached to the roof rack frame using two ladder clamps

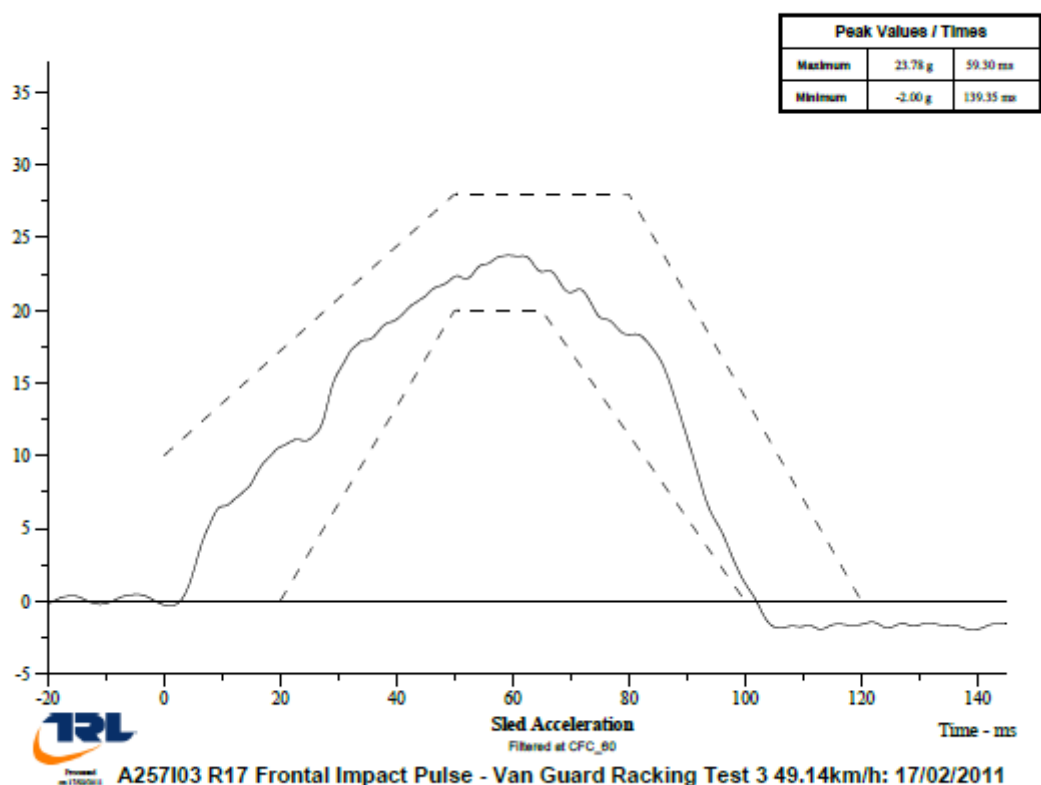
The deceleration pulse for the test was within the corridors specified in ECE Regulation 17.
