ULTI RACK™

Sled Test Summary

TRL Project Reference: PTG304

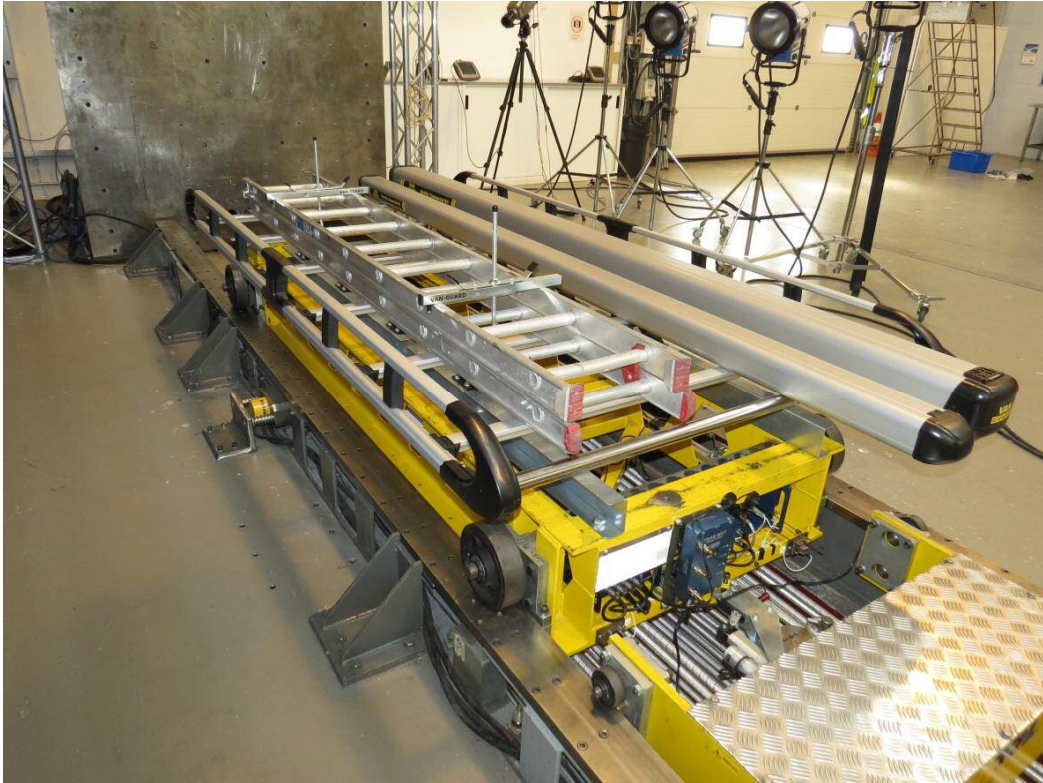
Figure 1. Test setup - G304I01

Test No. 1. (G304I01) No discernible movement of the test piece and no damage observed.

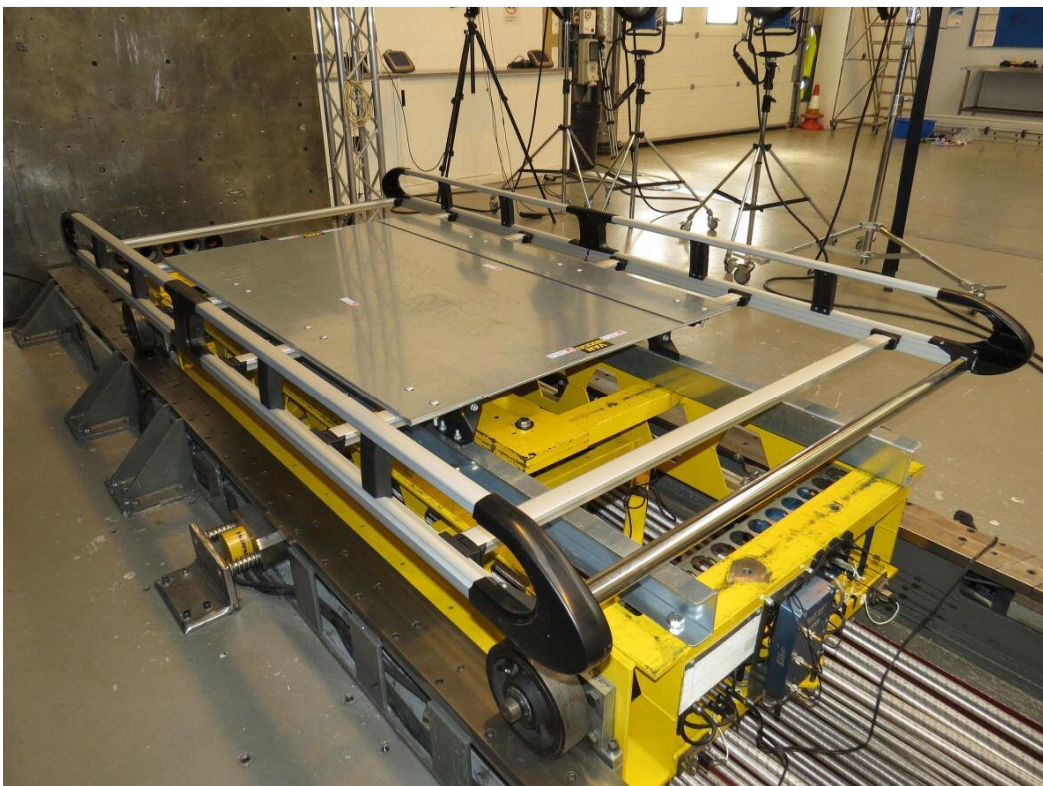
Figure 2. Test setup - G304I02

Test No. 2. (G304I02) No discernible movement of the test piece and only minor cracks to a couple of the rack cross-member clips were observed - these were so small, they appeared to have no significant effect on the integrity of the structure.
